**Flood Control Project Maintenance
Levee Inspections**

Fall 2013 Levee Maintenance Deficiency Summary Report

Reclamation District No. 0150 Merrit Island

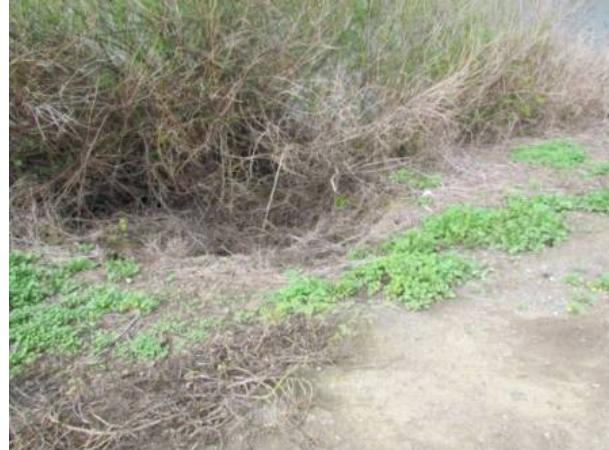
Levee Mile Report Line	26
Start Levee Mile	2.93
End Levee Mile	2.93
Location	Water Side
Category	Earthen Levee
Item	Slope Stability
Erosion was found on the waterside of the levee looking upstream. This picture was taken during spring 2012 inspection.	
pkazi_f_20131001_700.jpg

DWR ID: DWR_RD0150_03_s_2012_17	
26	2.93	2.93	Earthen Levee	Slope Stability	WS M Ma		S1 : Repair slope instability.	38.361375 °	38.361375 °	76 -121.562134 ° -121.562134 ° Y	
										DWR ID: DWR_RD0150_03_s_2012_76	
27	2.93	2.93	Earthen Levee	Crown Surface / Depressions / Rutting	CR C Ma		C3 : Add appropriate gravel or road base. Grade and compact.	38.361375 °	38.361375 °	75 -121.562135 ° -121.562135 °	
										DWR ID: DWR_RD0150_03_s_2012_75	
28	3.18	3.18	Earthen Levee	Trim / Thin Trees	WS C Ma		T2 : Thin trees to allow visibility of the ground and room to flood fight.	38.363800 °	38.363800 °	19 -121.560128 ° -121.560128 °	
										DWR ID: DWR_RD0150_03_s_2012_19	
29	3.21	3.21	Earthen Levee	Trim / Thin Trees	WS N Ma		T5 : Tree stumps.	38.363658 °	38.363658 °	20 -121.559583 ° -121.559583 ° Y	
										DWR ID: DWR_RD0150_03_s_2012_20

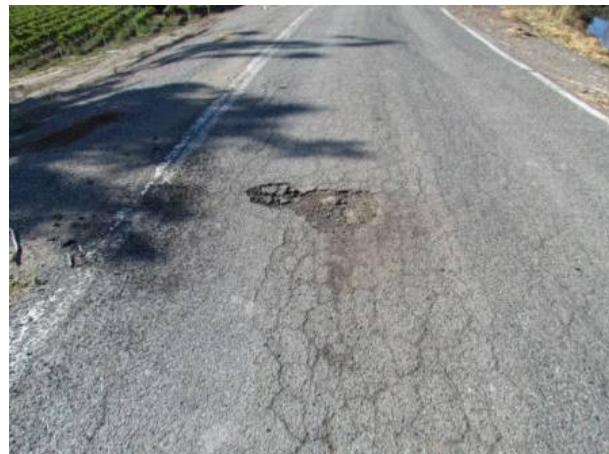
Levee Mile Report Line	30
Start Levee Mile	3.31
End Levee Mile	3.31
Location	Crown
Category	Earthen Levee
Item	Crown Surface / Depressions / Rutting
Crown depression was found on the access road looking downstream.	
pkazi_f_20131001_716.jpg

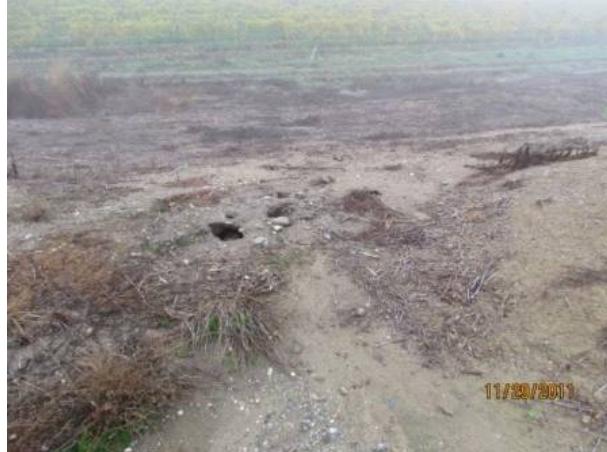
Levee Mile Report Line	31
Start Levee Mile	3.34
End Levee Mile	3.34
Location	Land Side
Category	Earthen Levee
Item	Animal Control
Rodent holes were found on the landside of the levee looking downstream.	
pkazi_f_20131001_693.jpg

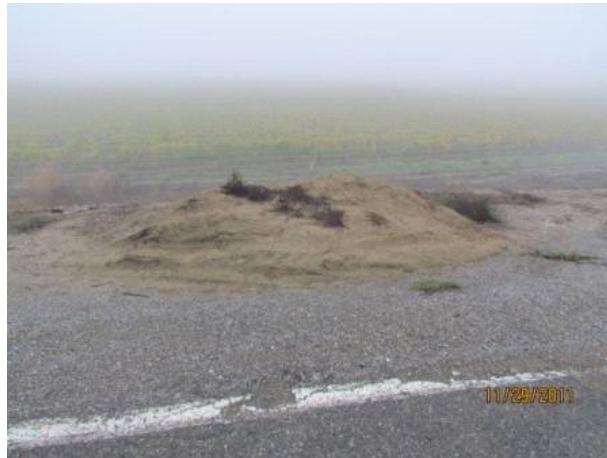
Levee Mile Report Line	32
Start Levee Mile	3.34
End Levee Mile	3.34
Location	Land Side
Category	Earthen Levee
Item	Encroachments
Material was found on the landside of the levee looking downstream.	
pkazi_f_20131001_695.jpg

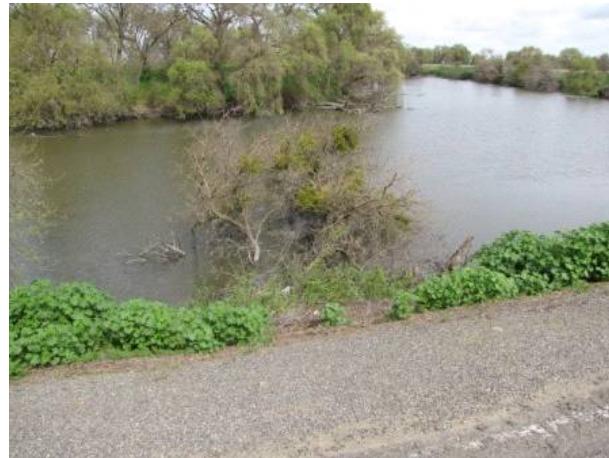
Levee Mile Report Line	36
Start Levee Mile	3.41
End Levee Mile	3.41
Location	Water Side
Category	Earthen Levee
Item	Trim / Thin Trees
View of tree stumps on the waterside slope looking upstream.	
pkazi_f_20131001_646.jpg

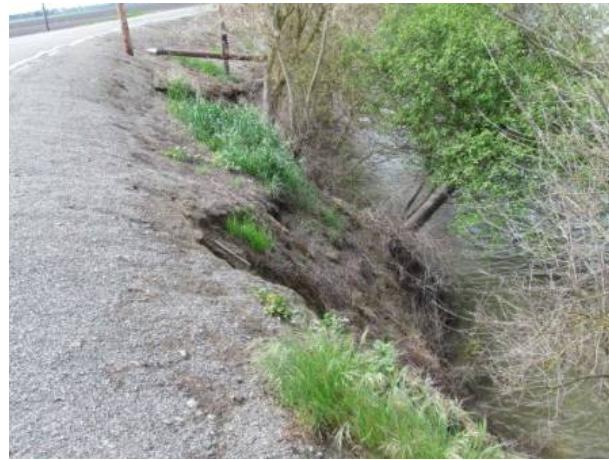
Levee Mile Report Line	39
Start Levee Mile	3.47
End Levee Mile	3.47
Location	Water Side
Category	Earthen Levee
Item	Erosion / Bank Caving
Erosion was found on the waterside of the levee looking downstream.	
pkazi_f_20131001_718.jpg

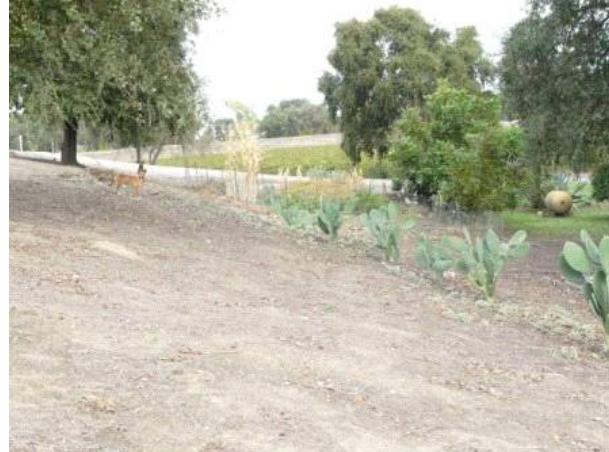
Levee Mile Report Line	40
Start Levee Mile	3.50
End Levee Mile	3.54
Location	Land Side
Category	Earthen Levee
Item	Vegetation
Landscaping & garden on landward slope of levee at LM 3.50 to LM 3.54.	
pkazi_f_20131001_664.JPG

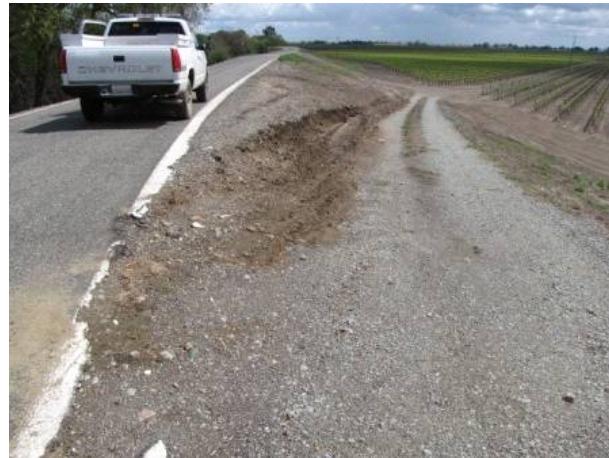
Levee Mile Report Line	44
Start Levee Mile	3.75
End Levee Mile	3.75
Location	Land Side
Category	Earthen Levee
Item	Slope Stability
Repair minor damage to levee slope along landward ramp at LM 3.75.	
pkazi_f_20131001_719.jpg

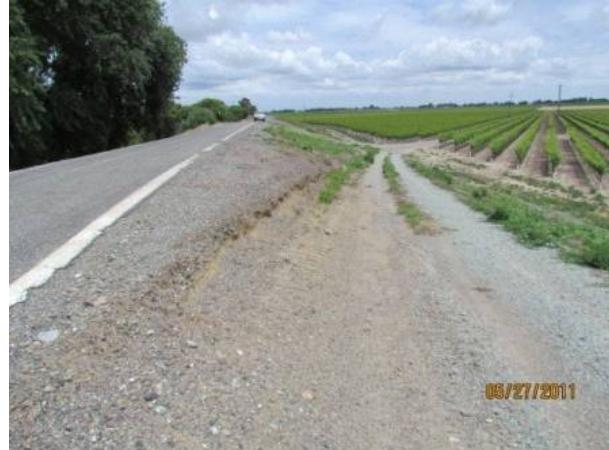
Levee Mile Report Line	44
Start Levee Mile	3.75
End Levee Mile	3.75
Location	Land Side
Category	Earthen Levee
Item	Slope Stability
Slope instability possible due to vehicular traffic on the landside of the levee. The picture was taken from the crown looking upstream during Spring 2011 inspection.	
pkazi_f_20131001_720.jpg

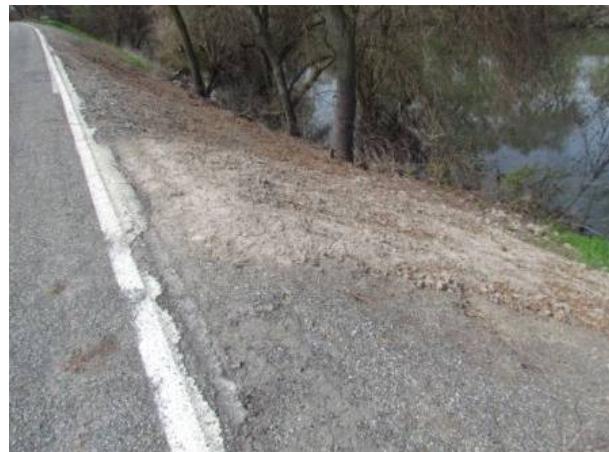
Levee Mile Report Line	45
Start Levee Mile	3.77
End Levee Mile	3.77
Location	Water Side
Category	Earthen Levee
Item	Slope Stability
Slope instability was repaired by the LMA on the waterside slope of the levee looking downstream.	
pkazi_f_20131001_662.JPG

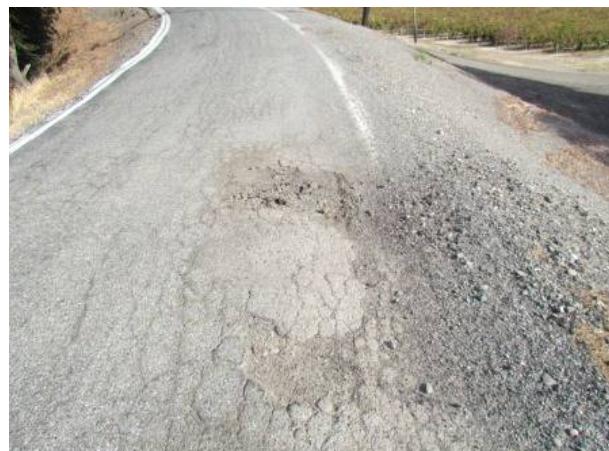
Levee Mile Report Line	48
Start Levee Mile	3.93
End Levee Mile	3.93
Location	Crown
Category	Earthen Levee
Item	Crown Surface / Depressions / Rutting
Crown depression was found looking upstream during the fall 2013 inspection.	
pkazi_f_20131029_022.JPG

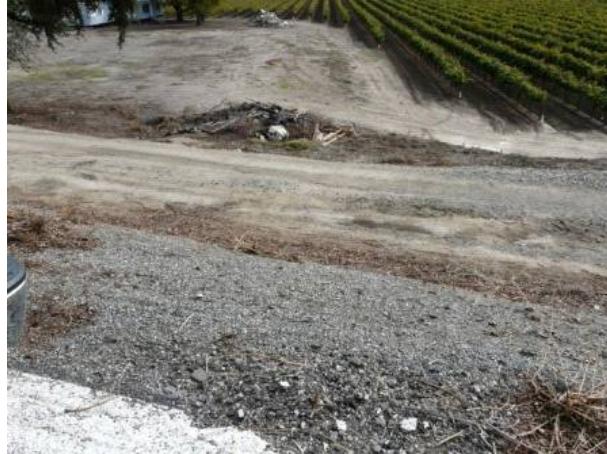
Levee Mile Report Line	49
Start Levee Mile	3.95
End Levee Mile	3.95
Location	Land Side
Category	Earthen Levee
Item	Encroachments
Debris pile on landward slope at LM 3.95.	
pkazi_f_20131001_665.JPG

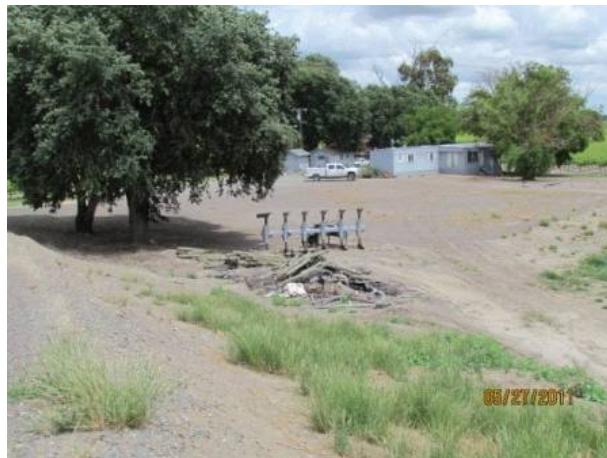
Levee Mile Report Line	49
Start Levee Mile	3.95
End Levee Mile	3.95
Location	Land Side
Category	Earthen Levee
Item	Encroachments
Debris found on the landside of the levee during Spring 2011 inspection. The picture was taken from the crown looking upstream.	
pkazi_f_20131001_667.jpg

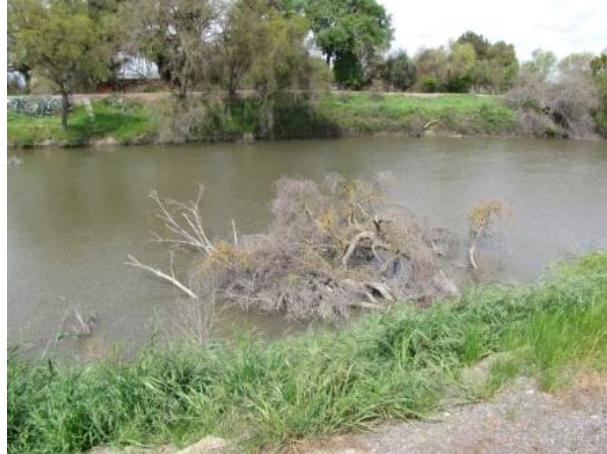
Levee Mile Report Line	50
Start Levee Mile	4.35
End Levee Mile	4.35
Location	Water Side
Category	Earthen Levee
Item	Trim / Thin Trees
View of tree stumps on the waterward slope.	
<i>pkazi_f_20131001_657.jpg</i>

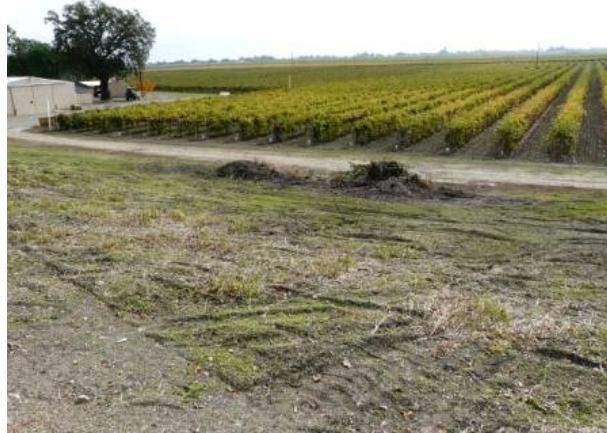
Levee Mile Report Line	51
Start Levee Mile	4.46
End Levee Mile	4.46
Location	Land Side
Category	Earthen Levee
Item	Encroachments
Remove pruning pile on landward slope at LM 4.46.	
<i>pkazi_f_20131001_670.JPG</i>

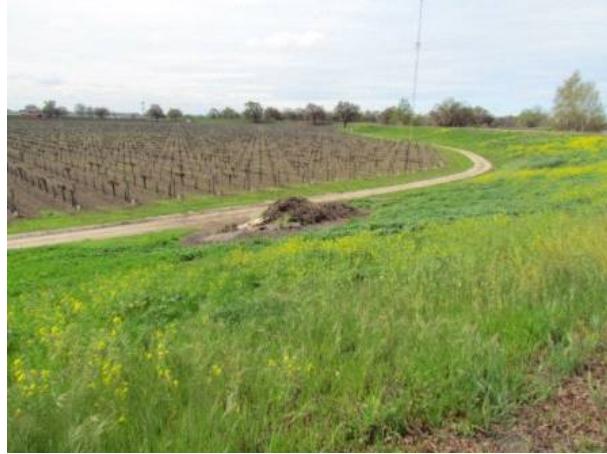
Levee Mile Report Line	51
Start Levee Mile	4.46
End Levee Mile	4.46
Location	Land Side
Category	Earthen Levee
Item	Encroachments
Pruning was found on the landside of the levee looking downstream.	
<i>pkazi_f_20131001_671.jpg</i>

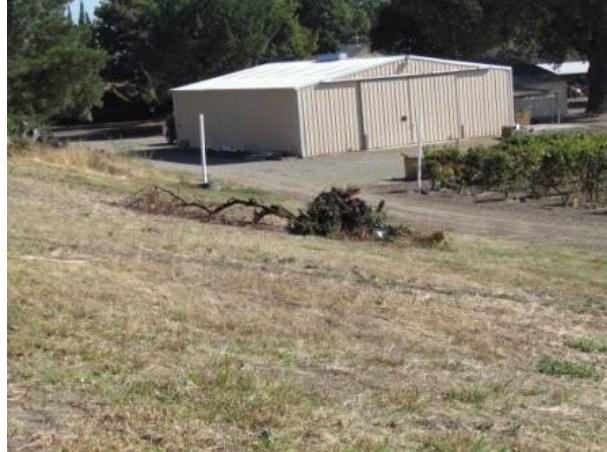
Levee Mile Report Line	51
Start Levee Mile	4.46
End Levee Mile	4.46
Location	Land Side
Category	Earthen Levee
Item	Encroachments
Pruning was found on the landside of the levee looking upstream. This picture was taken during fall 2012 inspection.	
pkazi_f_20131001_672.jpg

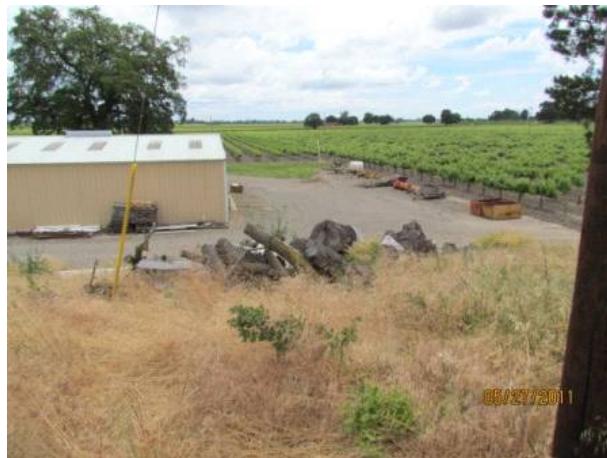
Levee Mile Report Line	52
Start Levee Mile	4.51
End Levee Mile	4.51
Location	Land Side
Category	Earthen Levee
Item	Encroachments
Tree branches were found on the toe of landside of the levee. The picture was taken from the crown looking downstream.	
pkazi_f_20131001_673.jpg

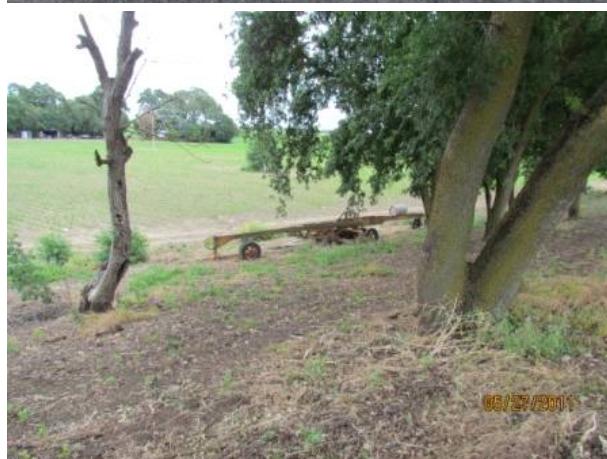
Levee Mile Report Line	56
Start Levee Mile	4.98
End Levee Mile	4.98
Location	Land Side
Category	Earthen Levee
Item	Encroachments
Equipment on the landside toe of the levee. The picture was taken from crown looking downstream.	
pkazi_f_20131001_633.jpg

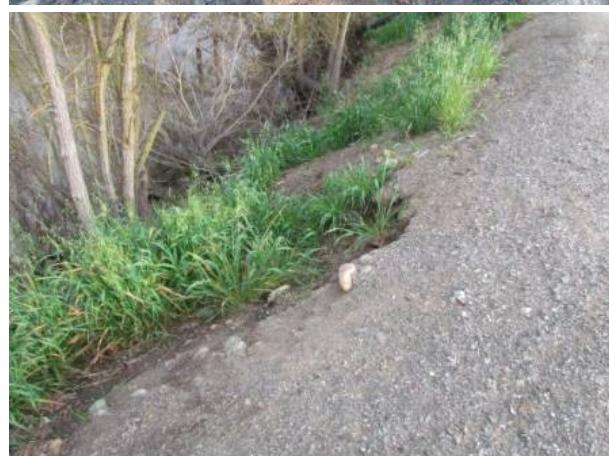
Levee Mile Report Line	59
Start Levee Mile	5.13
End Levee Mile	5.13
Location	Water Side
Category	Earthen Levee
Item	Slope Stability
Slope instability was found on the waterside of the levee looking upstream.	
pkazi_f_20131001_630.jpg

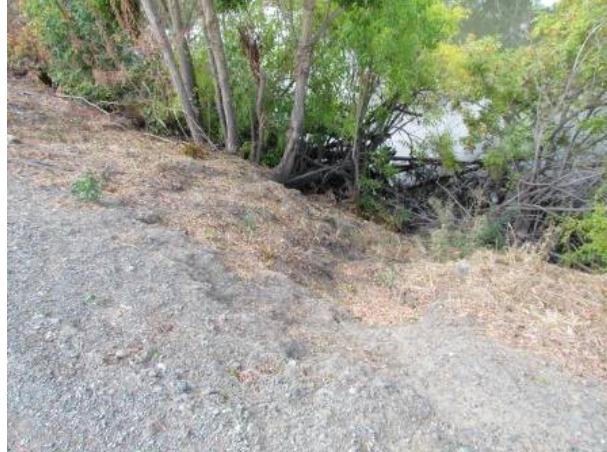
Levee Mile Report Line	59
Start Levee Mile	5.13
End Levee Mile	5.13
Location	Water Side
Category	Earthen Levee
Item	Slope Stability
Updated picture of the slope instability on the waterside slope of the levee looking downstream during the fall 2013 inspection.	
pkazi_f_20131029_024.JPG

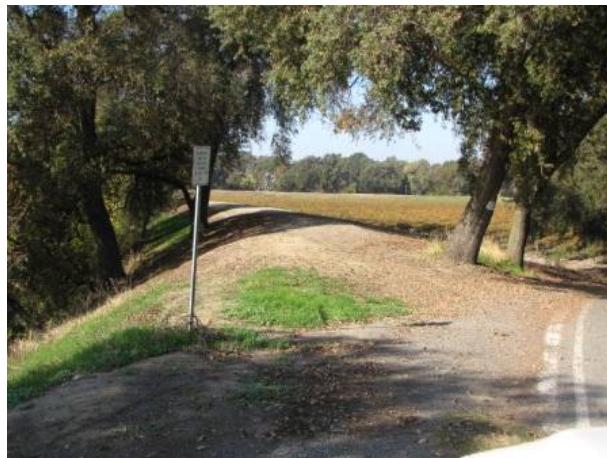
Levee Mile Report Line	61
Start Levee Mile	5.22
End Levee Mile	5.22
Location	Crown
Category	Earthen Levee
Item	Crown Surface / Depressions / Rutting
View of varying elevations in the crown of the levee at the transition from county road to access road.	
pkazi_f_20131001_728.jpg

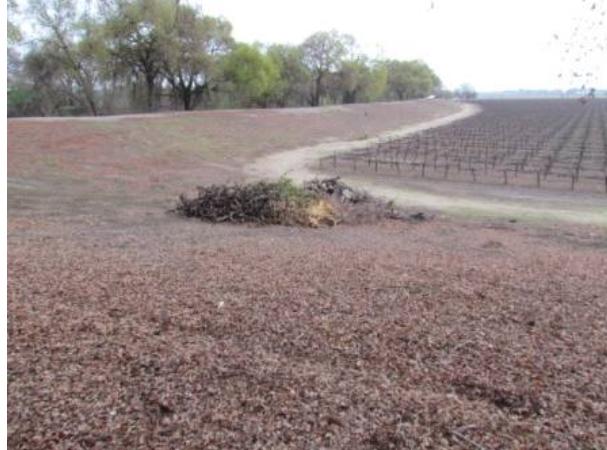
Levee Mile Report Line	62
Start Levee Mile	5.61
End Levee Mile	5.61
Location	Land Side
Category	Earthen Levee
Item	Encroachments
Prunings were found on the landside of the levee looking upstream.	
pkazi_f_20131001_635.jpg

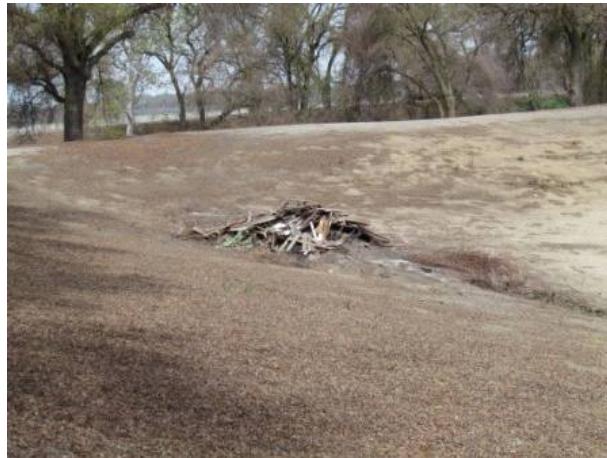
Levee Mile Report Line	62
Start Levee Mile	5.61
End Levee Mile	5.61
Location	Land Side
Category	Earthen Levee
Item	Encroachments
Updated picture of debris and pruning on the landside toe of the levee looking upstream. This picture was taken during spring 2013 inspection.	
pkazi_f_20131001_637.JPG

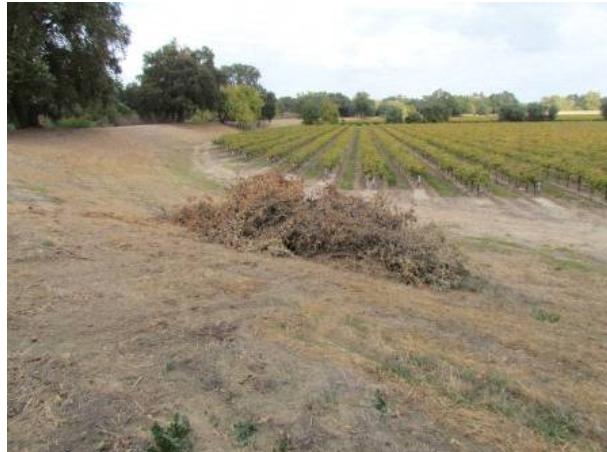
Levee Mile Report Line	62
Start Levee Mile	5.61
End Levee Mile	5.61
Location	Land Side
Category	Earthen Levee
Item	Encroachments
Updated picture of pruning pile on the landside toe of the levee looking upstream during the fall 2013 inspection.	
pkazi_f_20131029_026.JPG

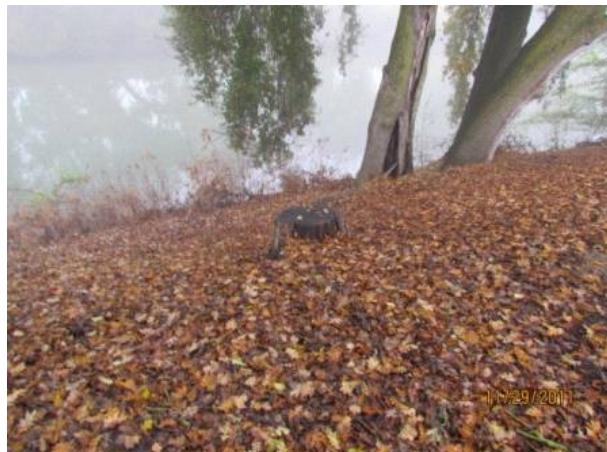
Levee Mile Report Line	63
Start Levee Mile	5.66
End Levee Mile	5.66
Location	Water Side
Category	Earthen Levee
Item	Trim / Thin Trees
Tree stump was found on the waterside of the levee looking upstream.	
pkazi_f_20131001_692.jpg

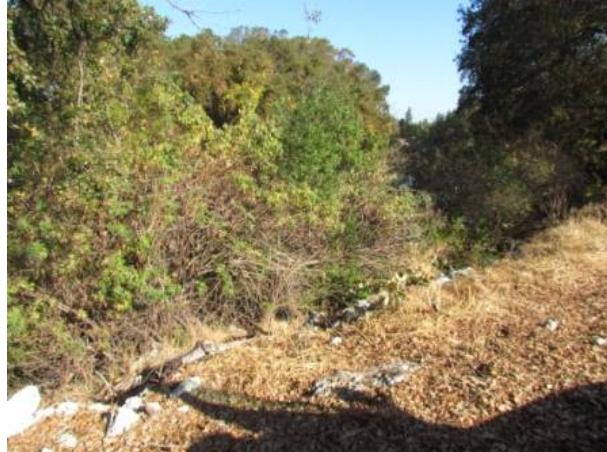
pkazi_f_20131001_647.jpg

Wild growth was found on the waterside slope of the levee looking upstream.

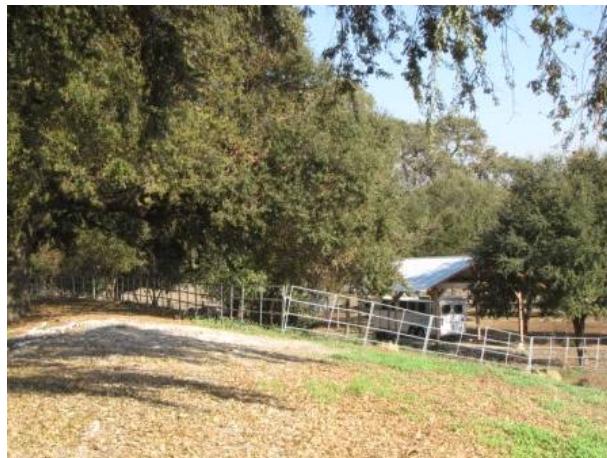
pkazi_f_20131001_675.jpg

Levee Mile Report Line	68
Start Levee Mile	5.89
End Levee Mile	5.94
Location	Land Side
Category	Earthen Levee
Item	Encroachments

View of fence around a horse pen along the shoulder of the levee and the landward slope.

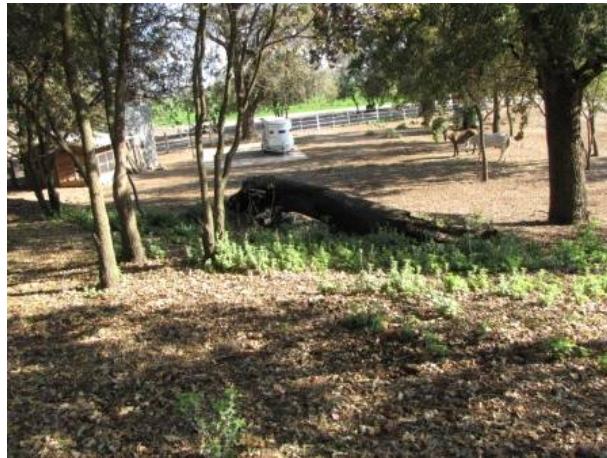
pkazi_f_20131001_676.jpg

Levee Mile Report Line	69
Start Levee Mile	5.93
End Levee Mile	5.93
Location	Land Side
Category	Earthen Levee
Item	Encroachments

View of a tree trunk lying on the landward slope blocking visibility.

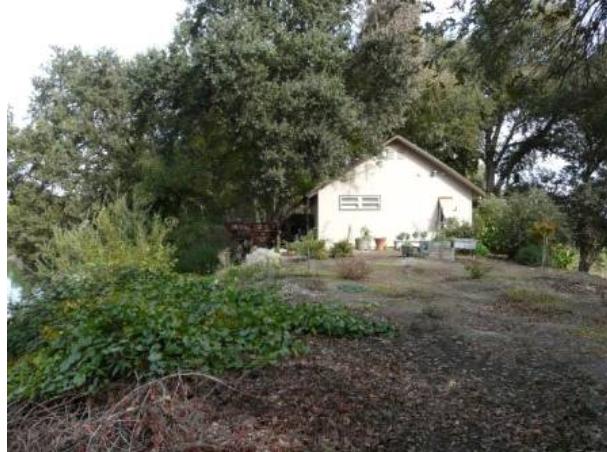
Levee Mile Report Line	70
Start Levee Mile	5.93
End Levee Mile	5.93
Location	Crown
Category	Earthen Levee
Item	Encroachments
Building & associated landscaping on levee crown at LM 5.93.	
pkazi_f_20131001_677.JPG

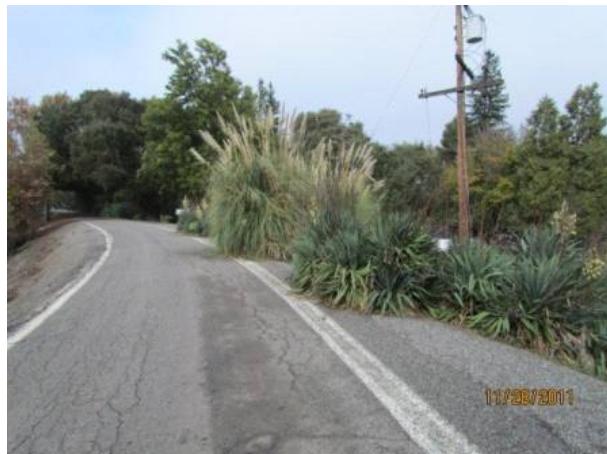
Levee Mile Report Line	71
Start Levee Mile	6.01
End Levee Mile	6.09
Location	Land Side
Category	Earthen Levee
Item	Vegetation
Landscaping was found on the landside of the levee looking upstream.	
pkazi_f_20131001_643.jpg

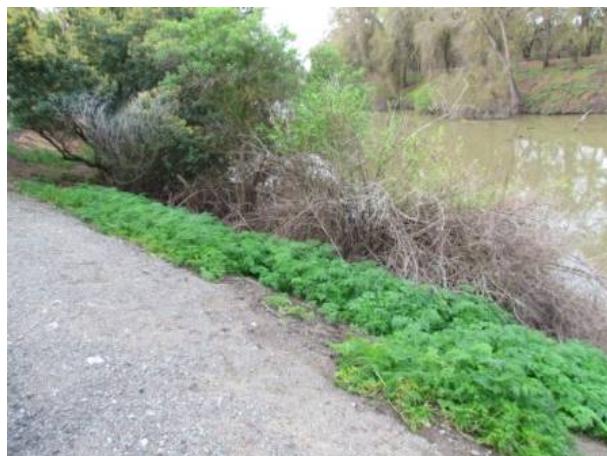
Levee Mile Report Line	72
Start Levee Mile	6.05
End Levee Mile	6.05
Location	Water Side
Category	Earthen Levee
Item	Trim / Thin Trees
Tree trunks and vegetation was obstructing the visibility on the waterside slope of the levee looking downstream.	
pkazi_f_20131001_653.jpg

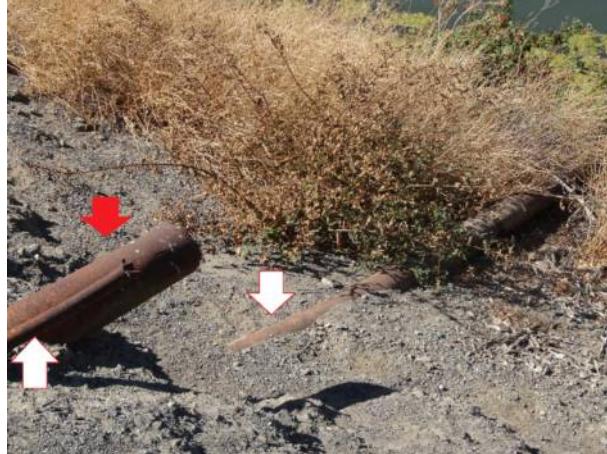
Levee Mile Report Line	73
Start Levee Mile	6.06
End Levee Mile	6.06
Location	Land Side
Category	Supplemental
Item	DWR UCIP Field Study
WS view: open ended 6" steel pipe (top-left), 1" steel pipe (bottom), and another 6" steel pipe (right) on levee slope.	UCIP_11733.jpg

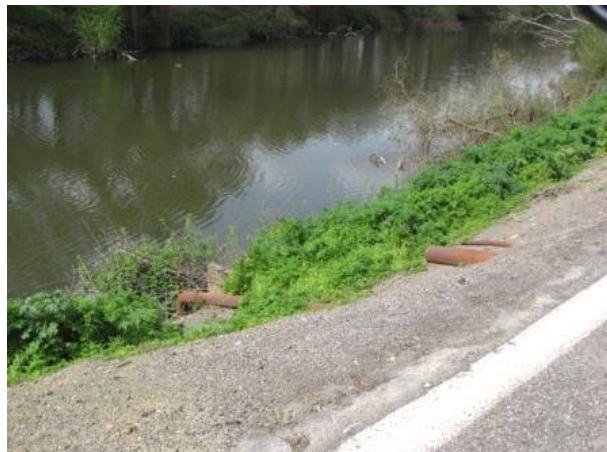
Levee Mile Report Line	74
Start Levee Mile	6.06
End Levee Mile	6.06
Location	Water Side
Category	Earthen Levee
Item	Encroachments
View of an improperly abandoned pipe through the levee looking upstream.	pkazi_f_20131001_663.jpg

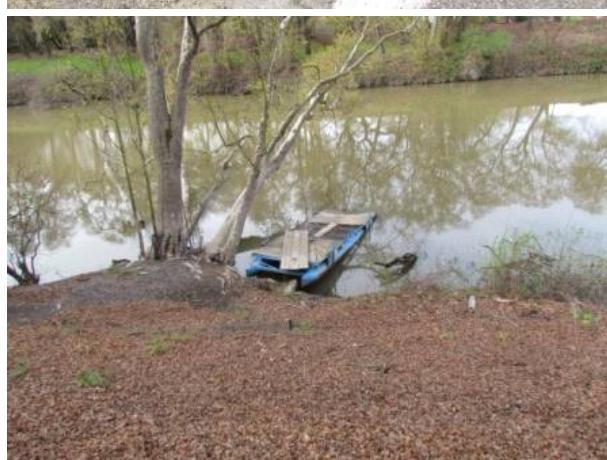
Levee Mile Report Line	75
Start Levee Mile	6.14
End Levee Mile	6.14
Location	Water Side
Category	Earthen Levee
Item	Encroachments
An abandoned dock was found on the waterside of the levee looking upstream.	pkazi_f_20131001_661.jpg

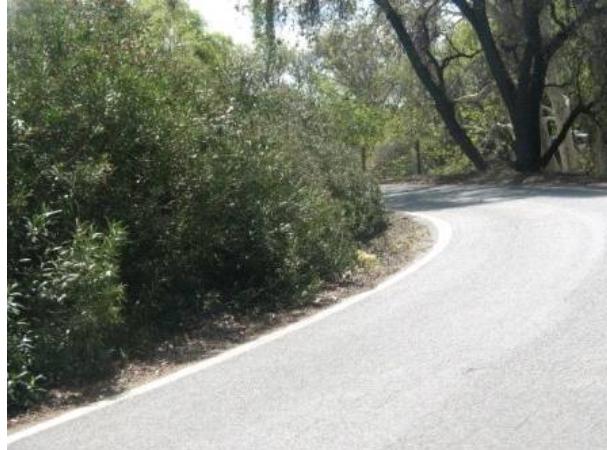
Levee Mile Report Line	77
Start Levee Mile	6.24
End Levee Mile	6.31
Location	Land Side
Category	Earthen Levee
Item	Vegetation
Oleander on landward slope blocking view of levee from LM 6.24 to 6.32	
pkazi_f_20131001_644.jpg

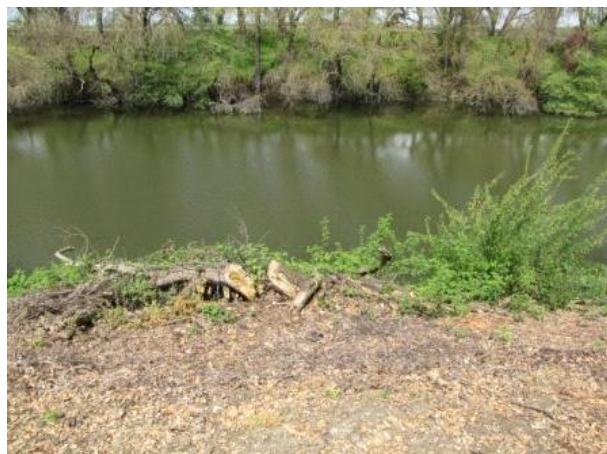
Levee Mile Report Line	78
Start Levee Mile	6.34
End Levee Mile	6.34
Location	Water Side
Category	Earthen Levee
Item	Trim / Thin Trees
View of tree stumps on the waterward slope.	
pkazi_f_20131001_668.jpg

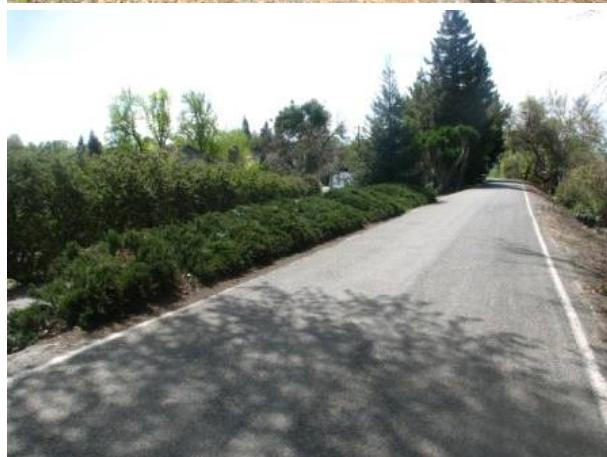
Levee Mile Report Line	80
Start Levee Mile	6.37
End Levee Mile	6.40
Location	Land Side
Category	Earthen Levee
Item	Vegetation
Landscaping on landward slope blocking view from LM 6.37 to 6.40	
pkazi_f_20131001_645.jpg

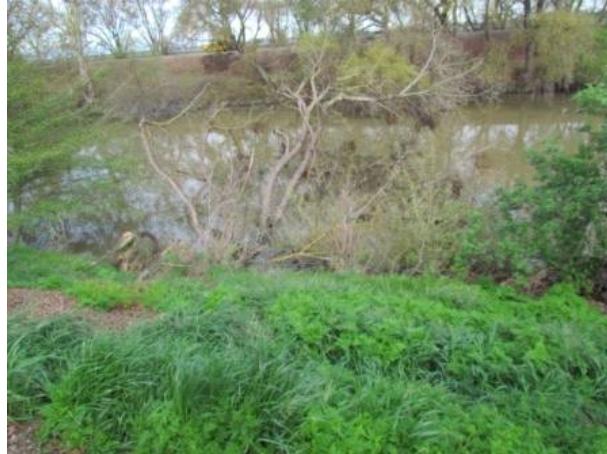
Levee Mile Report Line	81
Start Levee Mile	6.49
End Levee Mile	6.49
Location	Water Side
Category	Earthen Levee
Item	Trim / Thin Trees
Vegetation on the waterside of the levee looking downstream.	
pkazi_f_20131001_684.jpg

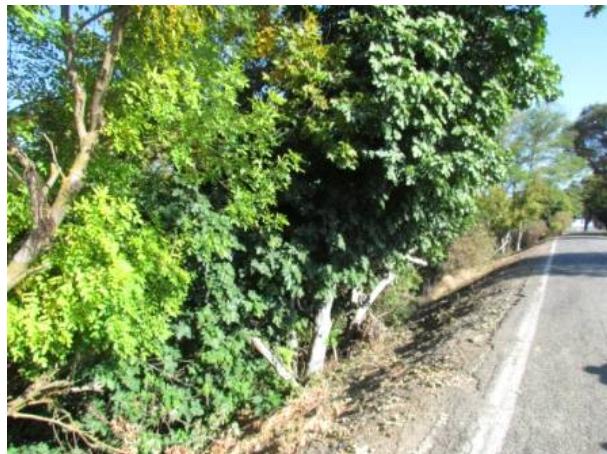
Levee Mile Report Line	81
Start Levee Mile	6.49
End Levee Mile	6.49
Location	Water Side
Category	Earthen Levee
Item	Trim / Thin Trees
Tree was blocking the visibility on the waterside of the levee looking upstream. This picture was taken during fall 2012 inspection.	
pkazi_f_20131001_685.jpg

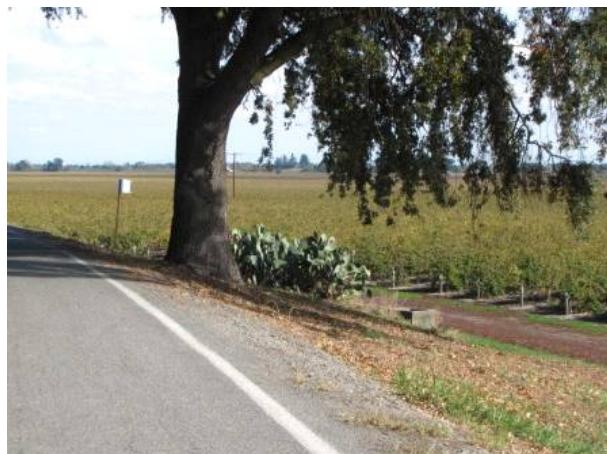
Levee Mile Report Line	82
Start Levee Mile	6.56
End Levee Mile	6.56
Location	Land Side
Category	Earthen Levee
Item	Vegetation
View of landscaping along the landward slope.	
pkazi_f_20131001_679.jpg

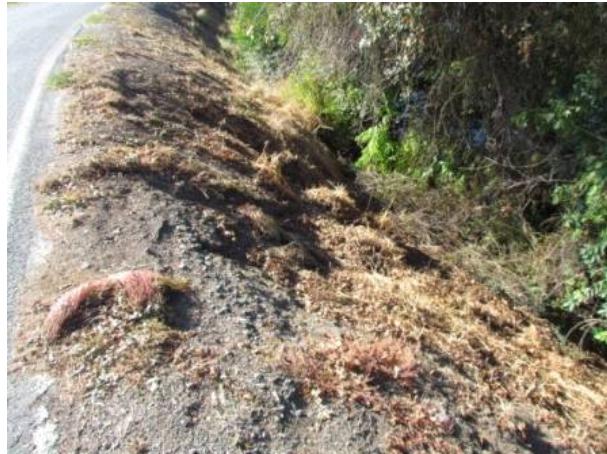
Levee Mile Report Line	83
Start Levee Mile	6.61
End Levee Mile	6.61
Location	Water Side
Category	Earthen Levee
Item	Slope Stability
Slope instability was found on the waterside of the levee looking downstream.	
<i>pkazi_f_20131001_660.jpg</i>

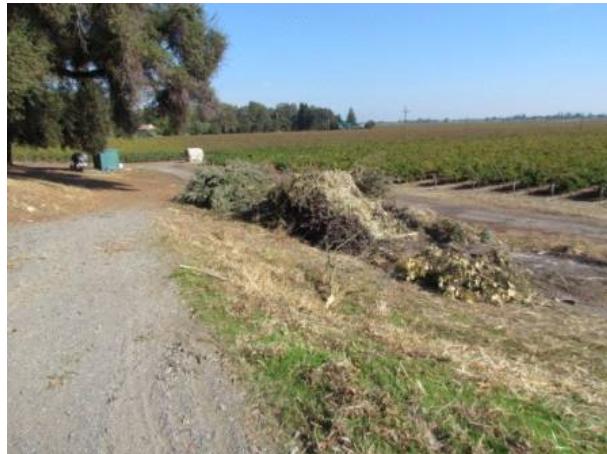
Levee Mile Report Line	84
Start Levee Mile	6.64
End Levee Mile	6.64
Location	Land Side
Category	Earthen Levee
Item	Encroachments
Prunings were found on the landside of the levee looking upstream.	
<i>pkazi_f_20131001_701.jpg</i>

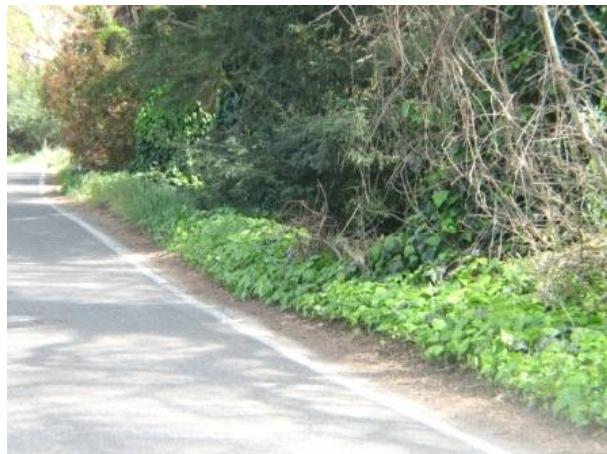
Levee Mile Report Line	85
Start Levee Mile	6.87
End Levee Mile	6.95
Location	Land Side
Category	Earthen Levee
Item	Vegetation
Landscaping on landward slope blocking view from LM 6.87 to 6.95	
<i>pkazi_f_20131001_649.jpg</i>

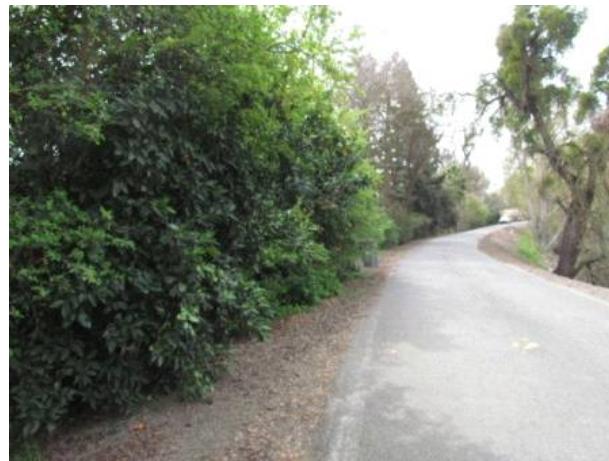
Levee Mile Report Line	87
Start Levee Mile	6.98
End Levee Mile	7.04
Location	Land Side
Category	Earthen Levee
Item	Vegetation
View of the landscape on the landside shoulder of the levee looking downstream.	pkazi_f_20131001_721.JPG

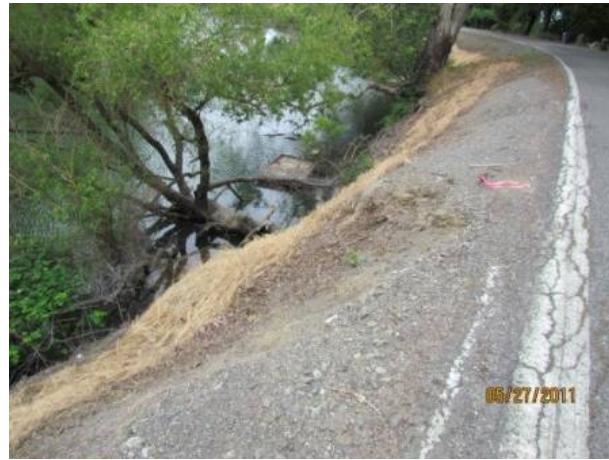
Levee Mile Report Line	89
Start Levee Mile	7.02
End Levee Mile	7.02
Location	Water Side
Category	Earthen Levee
Item	Erosion / Bank Caving
Updated erosion site picture on the waterside slope of the levee looking upstream during Spring 2011 inspection.	pkazi_f_20131001_680.jpg

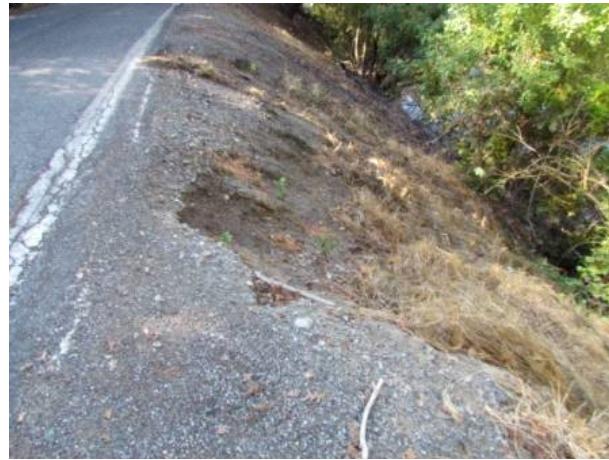
Levee Mile Report Line	89
Start Levee Mile	7.02
End Levee Mile	7.02
Location	Water Side
Category	Earthen Levee
Item	Erosion / Bank Caving
Erosion was found on the waterside slope of the levee looking downstream. This updated picture was taken during fall 2012 inspection.	
pkazi_f_20131001_683.jpg

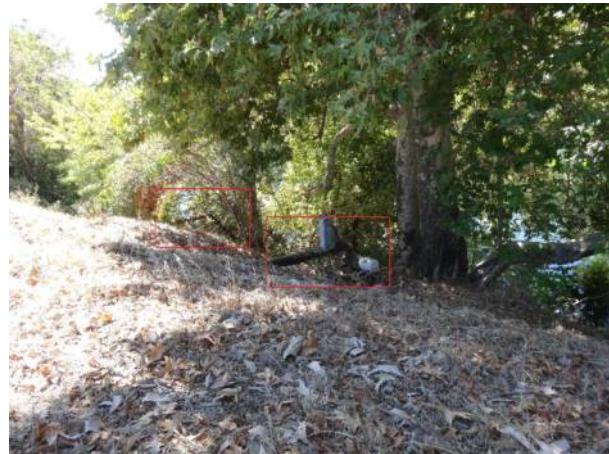
Levee Mile Report Line	91
Start Levee Mile	7.34
End Levee Mile	7.34
Location	Land Side
Category	Supplemental
Item	DWR UCIP Field Study
WS view: 8-inch pipe and pump on levee slope (right)	
UCIP_12141.jpg

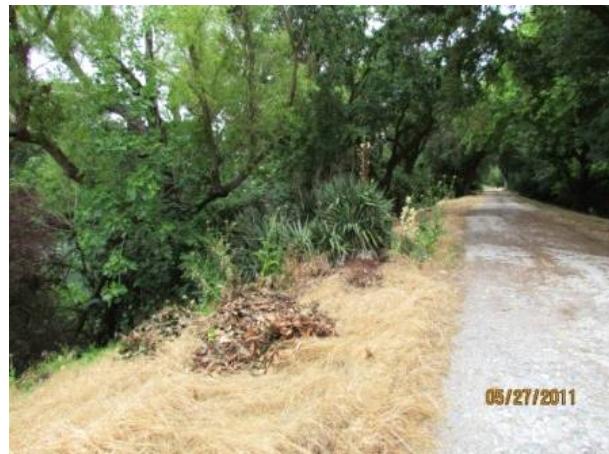
Levee Mile Report Line	92
Start Levee Mile	7.39
End Levee Mile	7.39
Location	Water Side
Category	Earthen Levee
Item	Vegetation
Landscaping on the waterside of the levee. The picture was taken from the crown looking upstream.	
pkazi_f_20131001_687.jpg

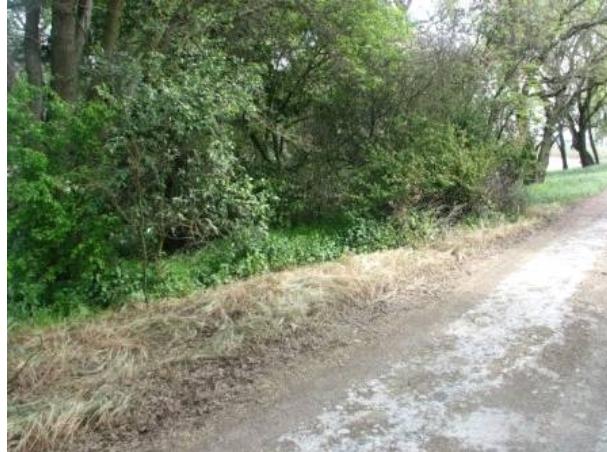
Levee Mile Report Line	93
Start Levee Mile	7.42
End Levee Mile	7.47
Location	Land Side
Category	Earthen Levee
Item	Vegetation
Landscaping on landward slope blocking view from LM 7.42 to 7.47	
pkazi_f_20131001_651.jpg

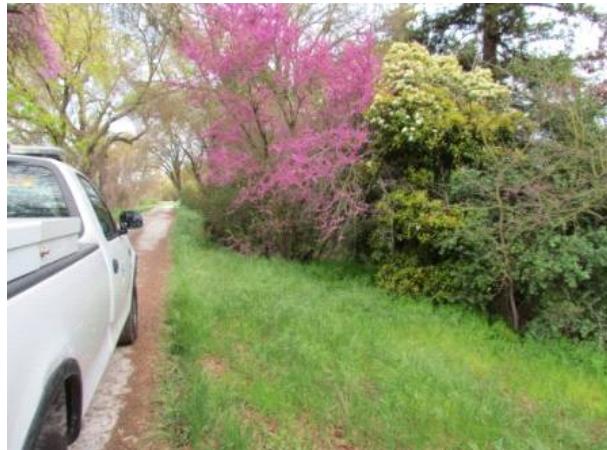
Levee Mile Report Line	93
Start Levee Mile	7.42
End Levee Mile	7.47
Location	Land Side
Category	Earthen Levee
Item	Vegetation
Vegetation on the landside of the levee looking upstream. This picture was taken during spring 2012 inspection.	
pkazi_f_20131001_652.jpg

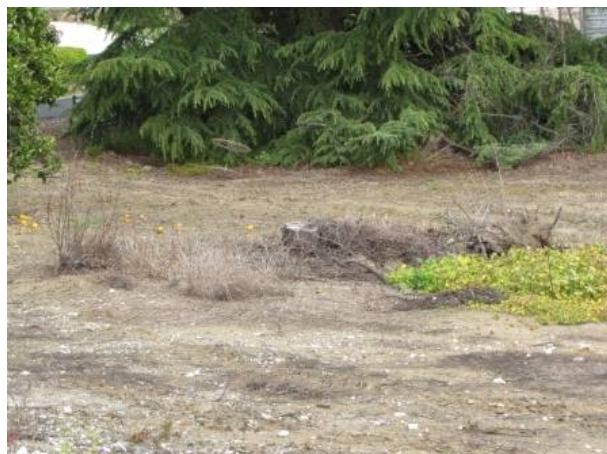
Levee Mile Report Line	94
Start Levee Mile	7.50
End Levee Mile	7.50
Location	Land Side
Category	Earthen Levee
Item	Trim / Thin Trees
View of a tree stump on the landward slope.	
pkazi_f_20131001_686.jpg

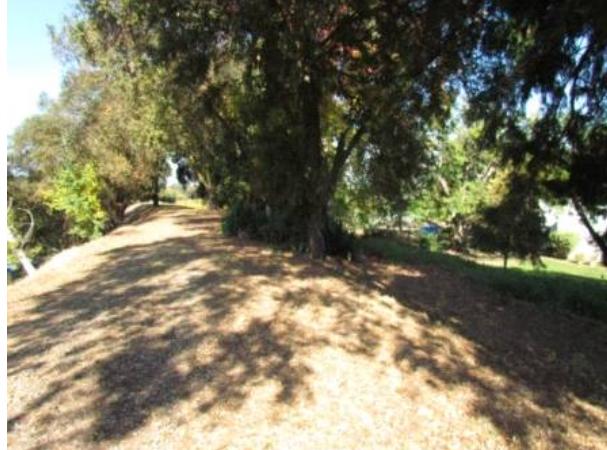
Levee Mile Report Line	95
Start Levee Mile	7.54
End Levee Mile	7.54
Location	Land Side
Category	Earthen Levee
Item	Vegetation
Landscaping was found on the landside shoulder of the levee looking upstream.	
pkazi_f_20131001_710.jpg

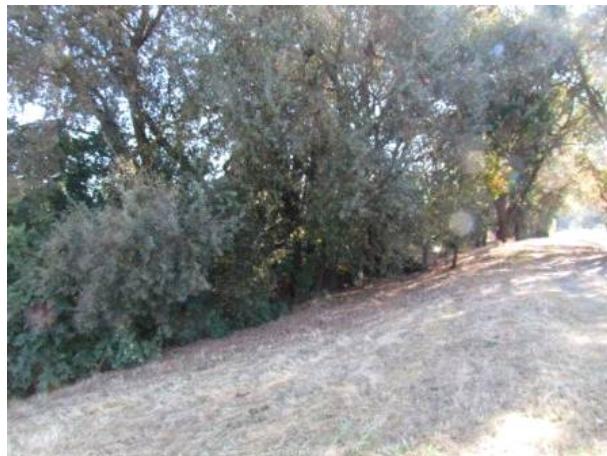
Levee Mile Report Line	96
Start Levee Mile	7.58
End Levee Mile	7.58
Location	Land Side
Category	Earthen Levee
Item	Vegetation
Landscaping was blocking the visibility on the landside of the levee looking downstream.	
pkazi_f_20131001_722.jpg

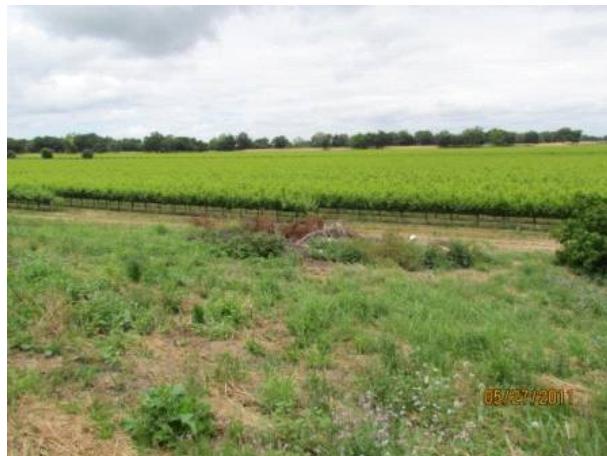
Levee Mile Report Line	97
Start Levee Mile	7.60
End Levee Mile	7.60
Location	Land Side
Category	Earthen Levee
Item	Encroachments
Prunings located on the toe of landward side of the levee. The picture was taken from the crown looking upstream.	
pkazi_f_20131001_723.jpg

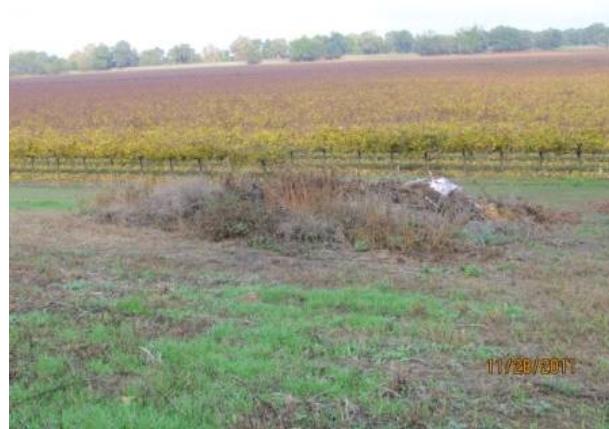
Levee Mile Report Line	97
Start Levee Mile	7.60
End Levee Mile	7.60
Location	Land Side
Category	Earthen Levee
Item	Encroachments
Prunings were found on the landside of the levee looking upstream. This picture was taken during fall 2011 inspection.	
pkazi_f_20131001_724.jpg

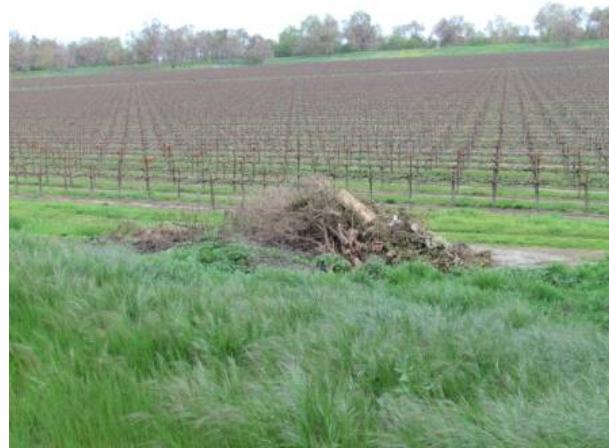
Levee Mile Report Line	97
Start Levee Mile	7.60
End Levee Mile	7.60
Location	Land Side
Category	Earthen Levee
Item	Encroachments
Prunings were found on the landside of the levee looking upstream.	
pkazi_f_20131001_725.jpg

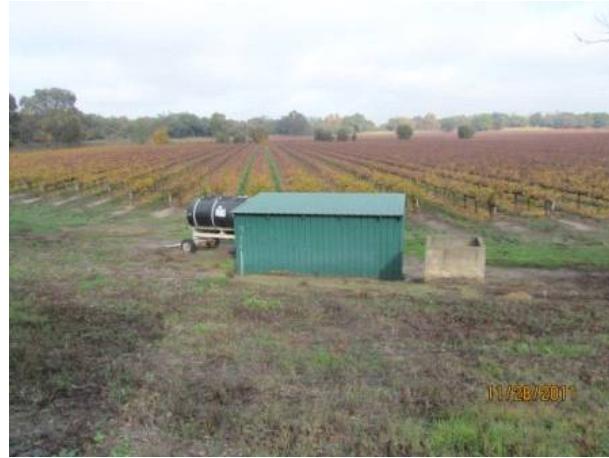
Levee Mile Report Line	99
Start Levee Mile	7.82
End Levee Mile	7.82
Location	Land Side
Category	Earthen Levee
Item	Encroachments
Equipment was found on the landside of the levee looking upstream.	
pkazi_f_20131001_639.jpg

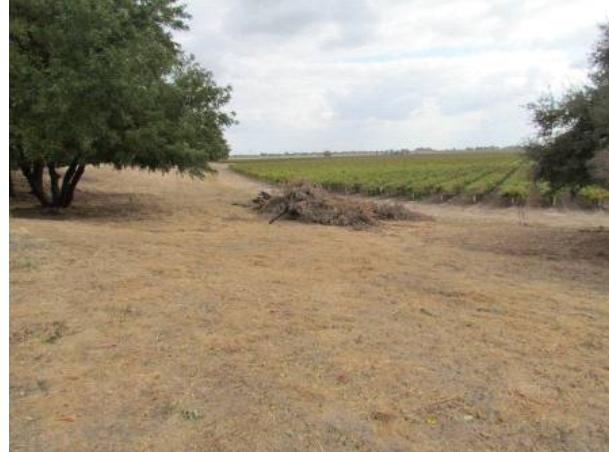
Levee Mile Report Line	100
Start Levee Mile	7.85
End Levee Mile	7.85
Location	Land Side
Category	Earthen Levee
Item	Encroachments
Prunings were found on the landside toe of the levee looking upstream.	
<i>pkazi_f_20131029_027.JPG</i>

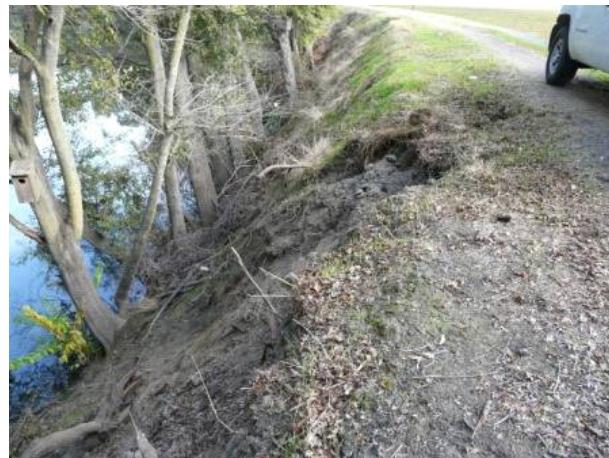
Levee Mile Report Line	104
Start Levee Mile	8.46
End Levee Mile	8.46
Location	Water Side
Category	Earthen Levee
Item	Erosion / Bank Caving
Repair erosion on waterward slope near shoulder at LM 8.46.	
<i>pkazi_f_20131001_689.JPG</i>

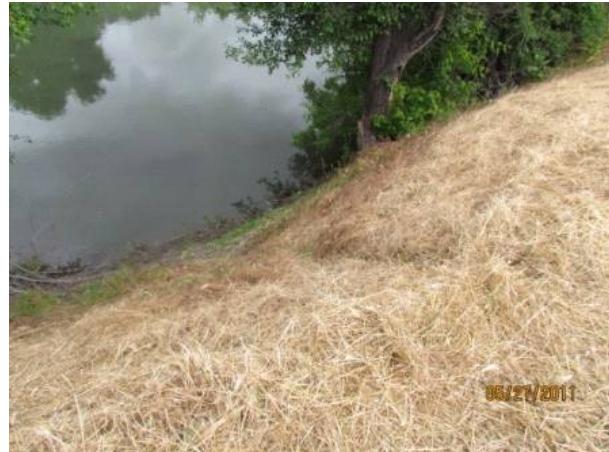
Levee Mile Report Line	105
Start Levee Mile	8.48
End Levee Mile	8.48
Location	Water Side
Category	Earthen Levee
Item	Erosion / Bank Caving
Slope instability on the waterside slope of the levee. The picture was taken from the crown looking upstream.	
pkazi_f_20131001_690.jpg

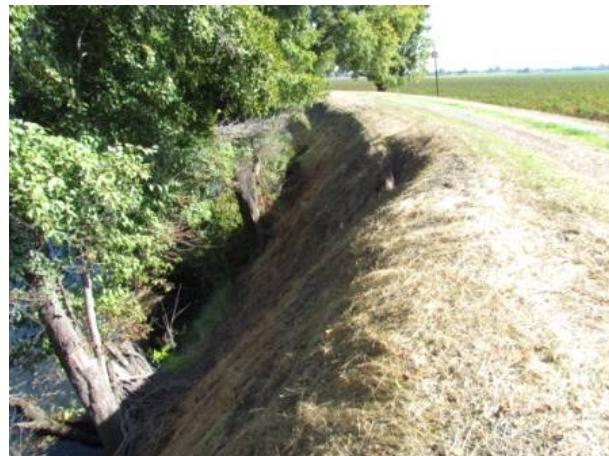
Levee Mile Report Line	105
Start Levee Mile	8.48
End Levee Mile	8.48
Location	Water Side
Category	Earthen Levee
Item	Erosion / Bank Caving
Slope instability was found on the waterside shoulder of the levee looking upstream. This picture was taken during fall 2012 inspection.	
pkazi_f_20131001_691.jpg

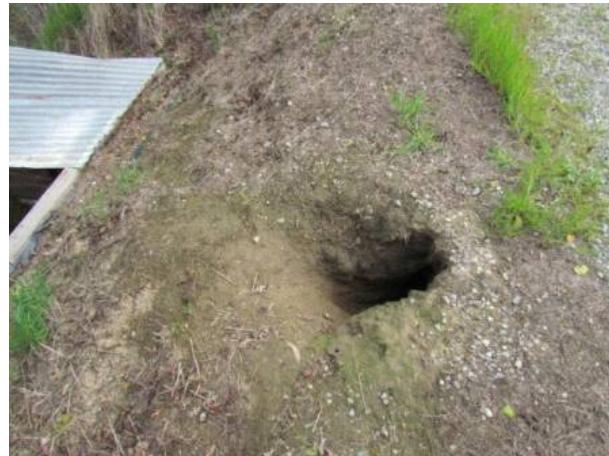
Levee Mile Report Line	106
Start Levee Mile	8.52
End Levee Mile	8.52
Location	Water Side
Category	Earthen Levee
Item	Animal Control
A rodent hole was found on the waterside of the levee looking upstream.	
pkazi_f_20131001_714.jpg

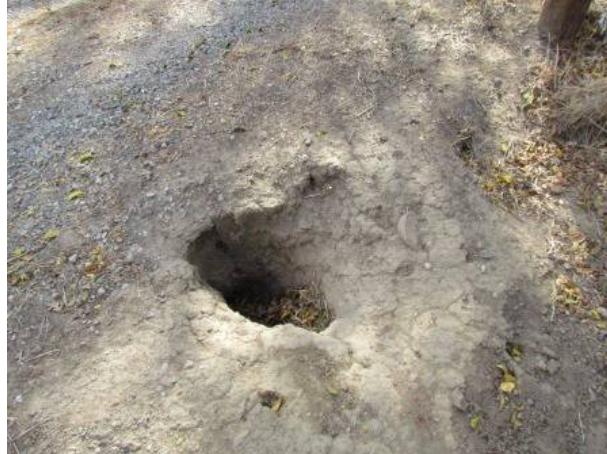
Levee Mile Report Line	106
Start Levee Mile	8.52
End Levee Mile	8.52
Location	Water Side
Category	Earthen Levee
Item	Animal Control
Updated picture of the rodent hole on the waterside shoulder of the levee looking downstream during the fall 2013 inspection.	
pkazi_f_20131029_028.JPG

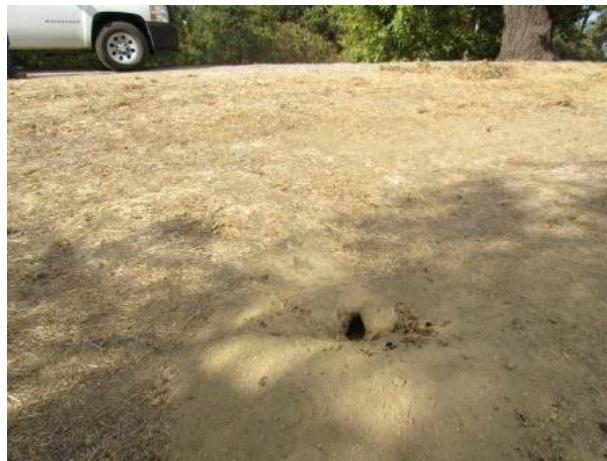
Levee Mile Report Line	109
Start Levee Mile	8.62
End Levee Mile	8.62
Location	Land Side
Category	Earthen Levee
Item	Animal Control
A rodent hole was found on the landside slope of the levee. The picture was taken from the landside toe looking towards the crown during fall 2013 inspection.	
pkazi_f_20131029_029.JPG
